## Willesley Park Golf Club

### Dilapidation Report No 2

#### Main Club House Building Roof

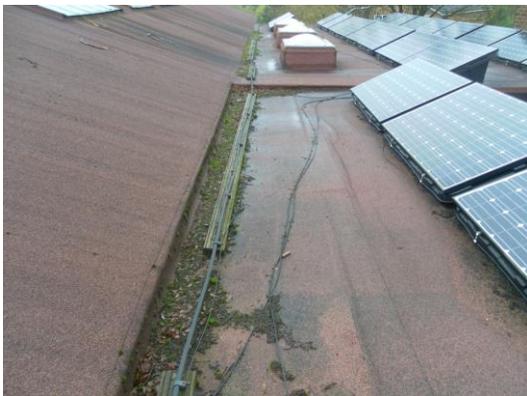
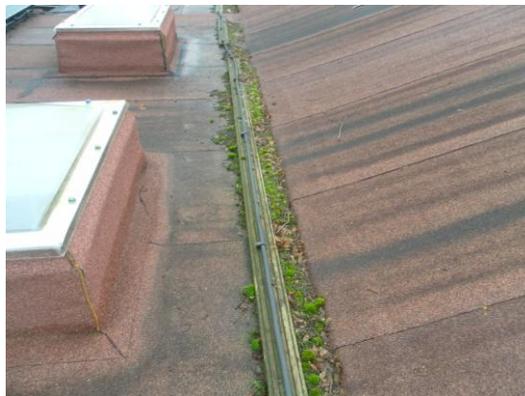
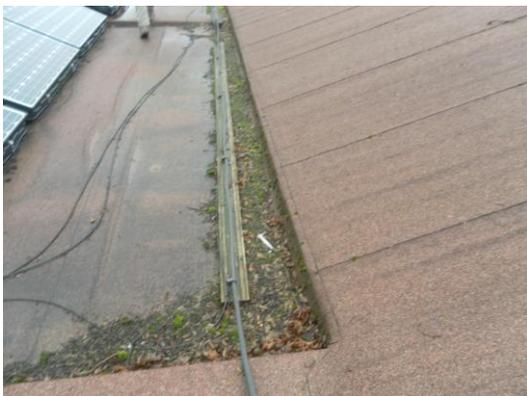
#### Main Roof Solar Panel Install

The following photos show that the main cables are connected to timber bearers which are left lying on the felted roof which cause leaf build up and water build up on the flat roof area. I believe this may be having an effect on the dampness coming through on the ceiling in the gents changing room. I also believe that all wiring should have been install within a cable tray system compliant to the regulations and raised up of the flat roof by means of brackets.

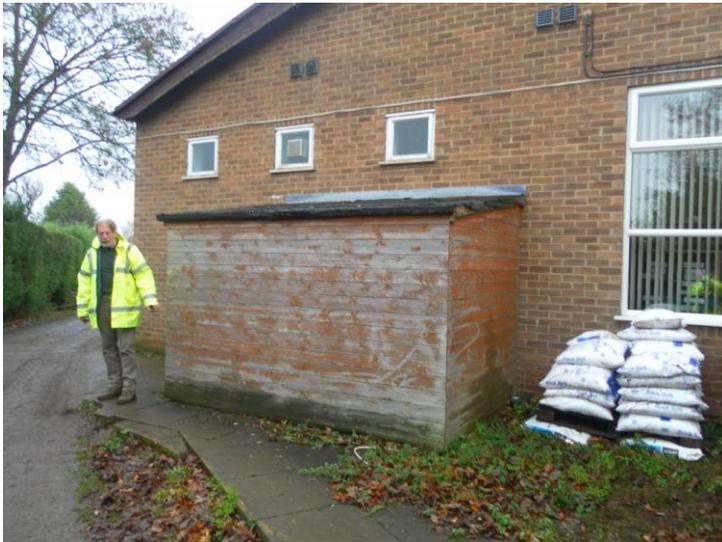
### Lean To shed to side of building

The photo shows that the roof felt has totally deteriorated to such an extent that the felt is broken down into fragments and is serving no purpose at all in protecting the sub structure. The timber cladding needs checked for stability and any rotten boards need removing and replaced also the whole structure needs coating with a correct timber preservative i.e. Cuprinal or similar protection paint.

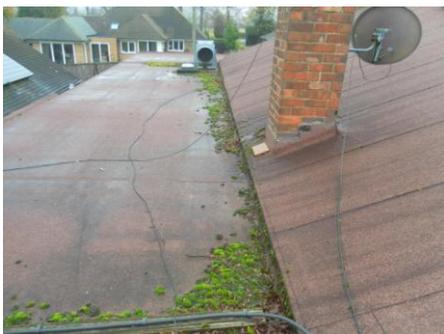
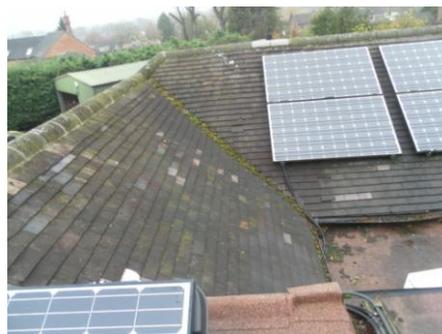
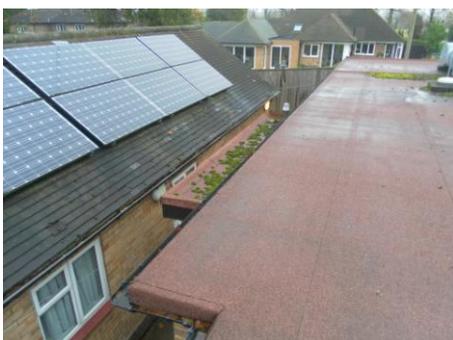
### Rear Flat Roof

The photos show that the roof felt is covered in moss which needs to be swept clean and maintained regularly to ensure that there is no further build up of moss or leaves on the roof. I would suggest that during winter months the roof is checked every quarter and in summer once to ensure the roof is kept clean and clear of rubbish and moss.

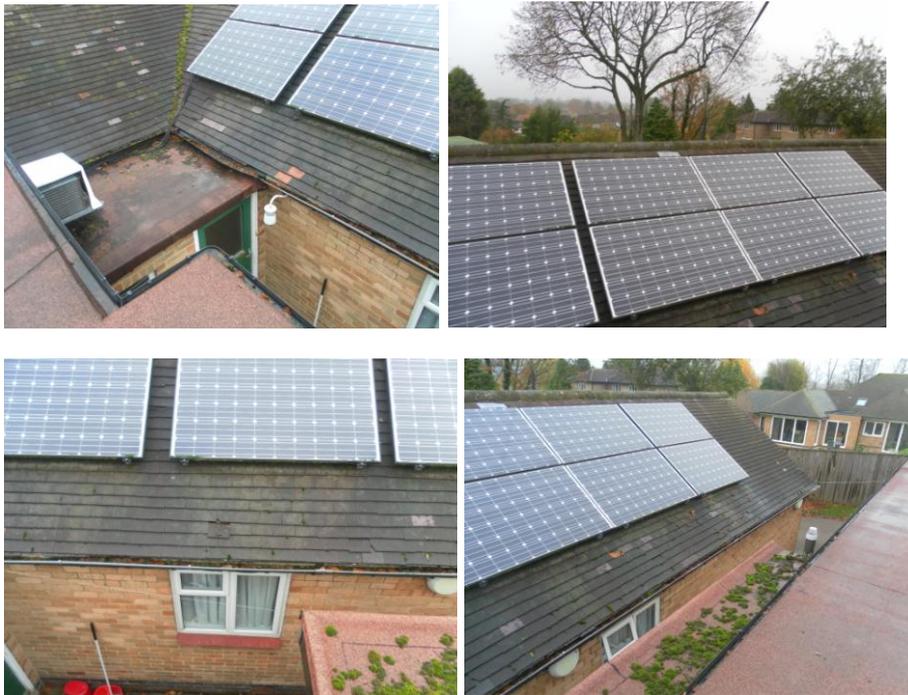
### Caretakers House Roof

The photos show that we have various roof tiles missing and the piece of guttering above the entrance porch requires changing as it seems to be buckled and not fitted correctly. The gutters need a good clean out and would also recommend investigating the down pipes leading from the gutters as these could be blocked with sludge and leaves. The guttering to the rear flat roof requires some major attention urgently as the gutter is not set in position correctly to allow the rain water to flow away correctly and the roof felt overhanging ends are lying in the gutter stopping the rain water from running away and again the leaves in gutters need cleaning out. Also note on the bungalow roof various tiles missing.

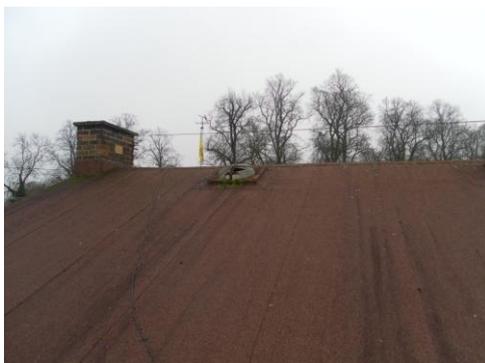
### The Main Club Roof

One of the roof cowlings is broken and needs covering over as soon as practically possible, I am not sure how long this has been broken but with all the heavy rain we have had in the last few weeks I would imagine we will have had some rain water penetration. Des is aware of this and it is a priority to get the cowling covered with thick polythene or felt for the short term however we do need to get this damaged cowling replaced as soon as possible.

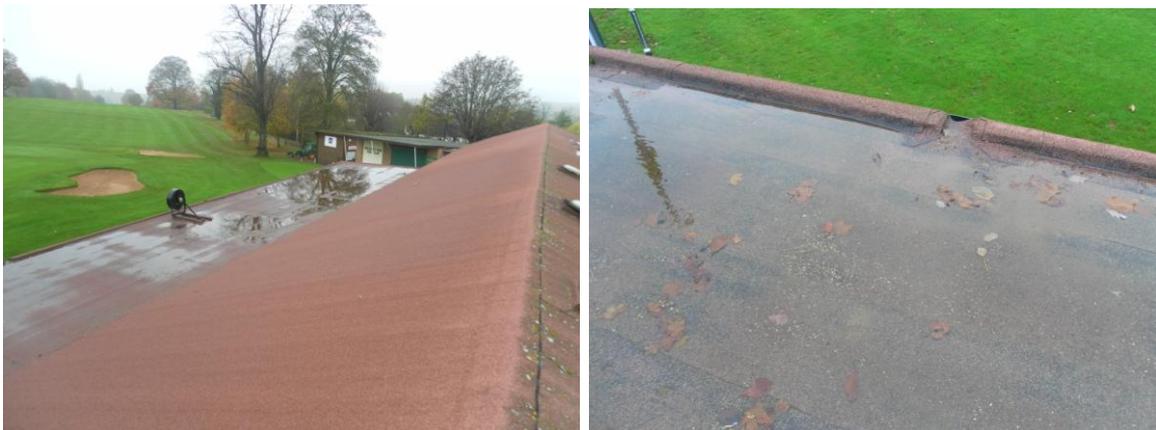
## **The Front Flat Roof**

This roof is a problem waiting for us in the near future, you will note that in the photos that there is a lot of standing water which through time soaks through the felt and the roof membrane and eventually will show u as water stains in the restaurant area of the club house and on the lining board soffit on the outdoor seating area. You will also see on the photo that the drainage route to the down pipe is higher than the roof area which dowse not allow the rain water to run of as it should there are two outlets on this roof and both are set higher. I would also suggest that the run on the roof is not adequate either through time the roof has sagged due to movement in the building or the run was not adequate at the time of the build whatever it is I would suggest that this roof needs looking at and a plan put in place to rectify the problem.
